Use Attainability Analysis
for
Water Body Identification # 2985
Turkey Creek

Conducted by:
Environmental Resources Coalition

Stream Description – WB ID: 2985 – Turkey Creek

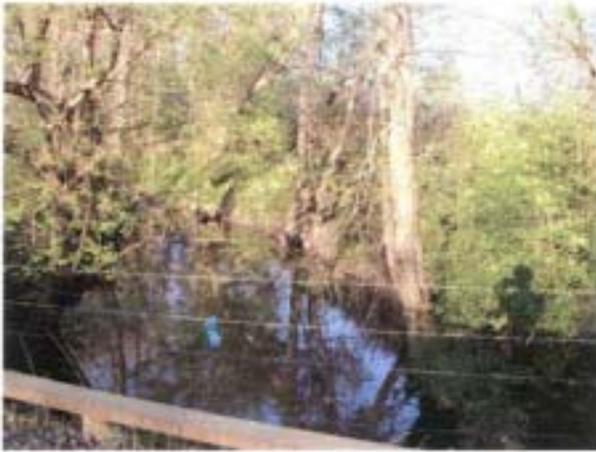
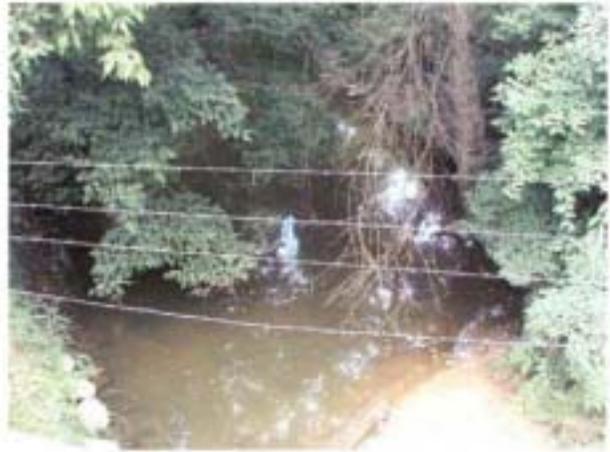
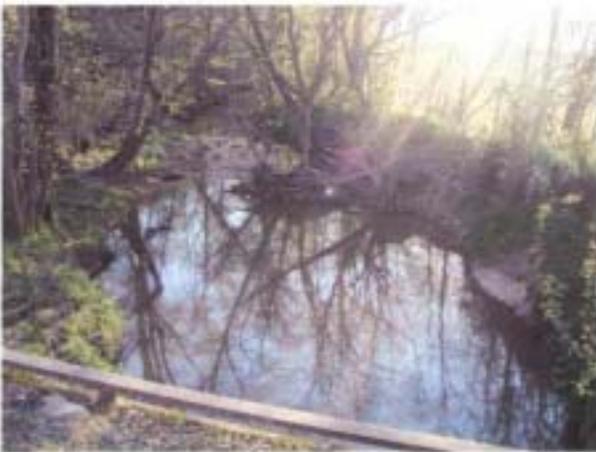
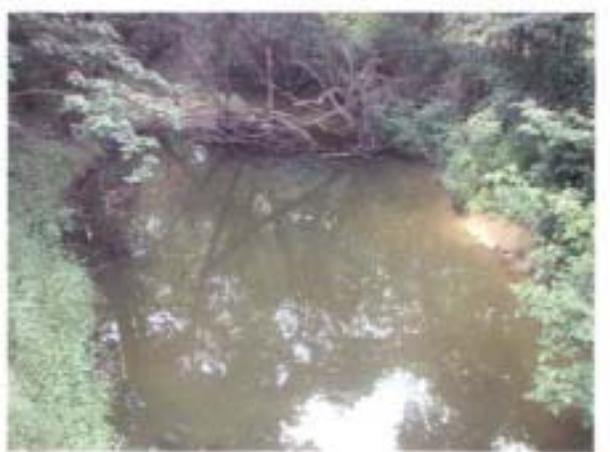
Site # 2 - County Rd 295 (Eygypt Church Rd)

Site #2: Site #2 of Turkey Creek is located on County Road 295. At this location there is approximately 170 feet of the stream that is accessible by the roadway. The upstream side of this stream is entirely fenced off. This site has steep banks making access to stream difficult. The surrounding area is composed primarily wooded areas and farm pastures. The water body has a lot of trash dumped in it including broken beer bottles. Concrete slabs with visible re-bar line some of the bank and bed of the stream.

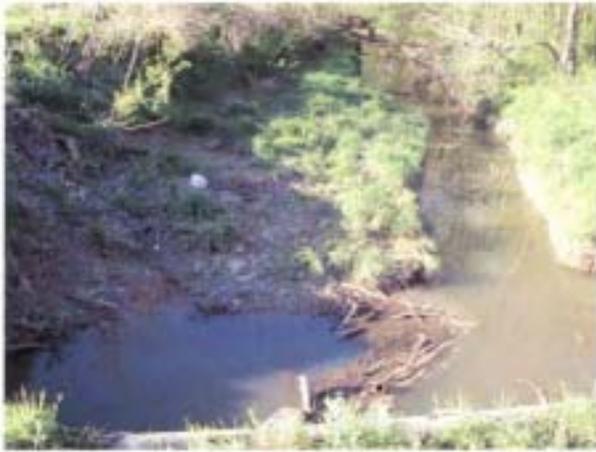
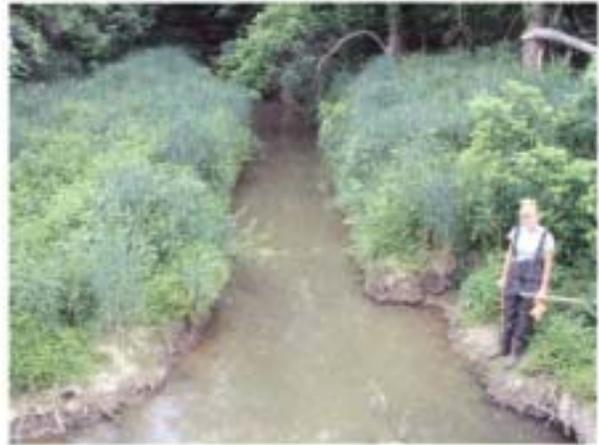
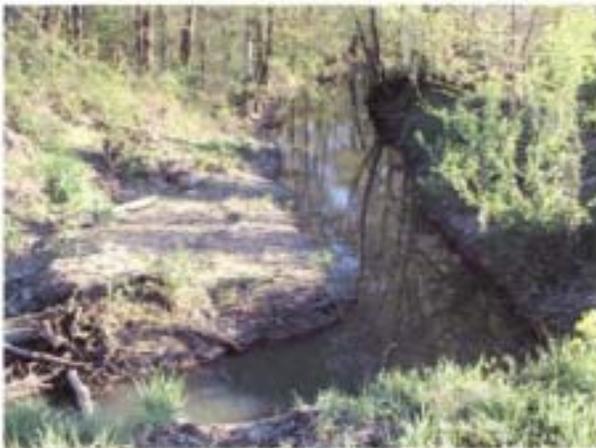
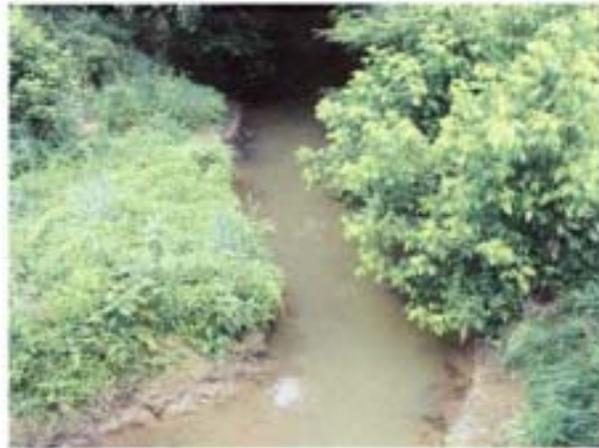
Site # 3 - Off Hwy T

Site #3: Site #3 of Turkey Creek is located on Highway T, and is surrounded by farm fields and wooded areas. There was trash in the stream possibly from upstream sites and from traffic on Highway T. A large amount of woody debris has collects at this site due to the road culvert. During field assessments this site the water surface of the stream had either organic foam or oily film present.
